MACHINE SERVICE BULLETIN NO. 257

SUBJECT: Carriage Shift of LA-5
and LA-6 Machines

DATE: July 31, 1939

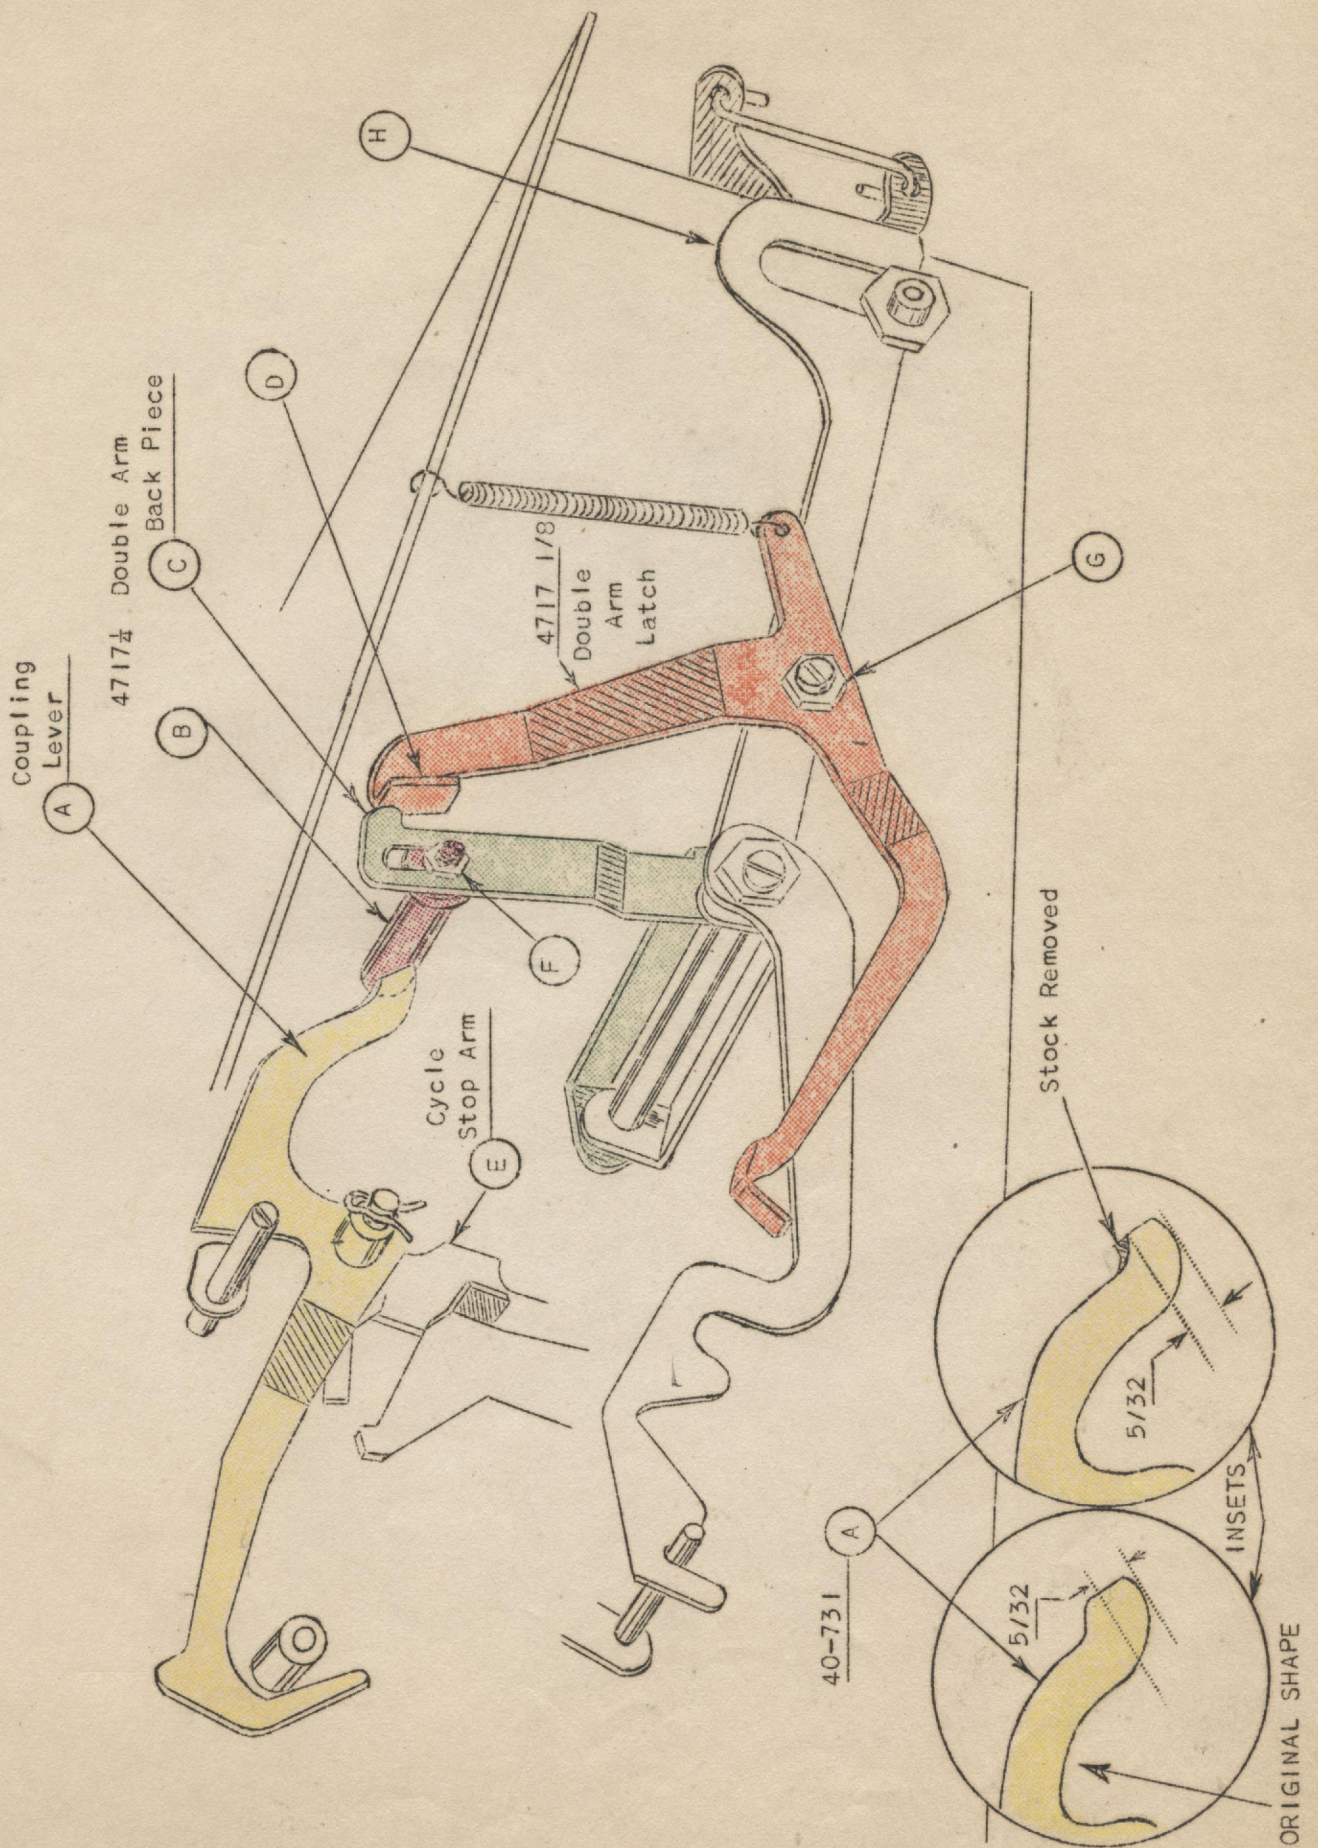
In order to obtain a satisfactory shift of the carriage on LA-5 and LA-6 model machines after all regular adjustments have been checked, servicemen have occasionally resorted to taking up on the clutch on the jack shaft until it failed to function as a slip clutch. To eliminate the need of such a practice, we suggest the removal of stock from the 40-731 coupling lever as illustrated on Plate 2 of this bulletin and the readjusting of the double arm latch 4717 1/8. Heretofore offset (D) was adjusted to (C) so that when the division lever was moved into operating position, (D) would latch under the step of (C) with as little excess clearance as possible and in order to insure the latching of (D) the 4717 1/8 was adjusted somewhat low. The natural result of this low adjustment was a loss of shift mechanism movement.

To provide an upward adjustment of the 4717 1/8 by means of eccentric (G) without the possibility of it failing to latch under the step of (C) during the minus bumper stroke following an over-carry trip, stock could be removed from (A) as shown in the insets on Plate 2. The absence of this stock permits (C) to pivot rearward slightly more during the minus bumper stroke, thereby, allowing offset (D) to latch with (C) although the 4717 1/8 was adjusted higher than previously. Also, it is no longer necessary for (D) to latch under the step of (C) when the division lever is moved toward the carriage.

It will be interesting to note that after making this adjustment, (H) will be moved downward its entire distance before (A) starts to move under roller (B), thus proving that the grinding out of stock does not cause any loss of shift power.

Roller (B) can be adjusted lower by loosening nut (F). However, its downward adjustment is limited due to interference with a stud on the machine stopping lever.

The journey of the cycle stop arm (E) to the bumper pad following an overcarry trip in minus, causes an idle movement of (A) in relation to (B), but following an over-carry trip in plus, (A) contacts and pushes (B) forward, causing a carriage shift.

After doing this it will be found that the slip clutch can be let out (friction reduced) considerably without retarding the carriage shift.
